PROJECT FAQs
AND
UPDATES

10864 MADRONA DRIVE
FORESHORE SLOPE STABILIZATION
1200092
00-0101

On March 11, 2020, I visited 10664 Madrona Drive (Figures 1 and 2) to meet with the owner, and review the condition of the Marine Uplands and Foreshore Development Permit Area (MUFDP), (which is 15m from the natural boundary of the sea), to assess the MUFDP with regard to erosion that is occurring along the shoreline within the MUFDP.

Environmental Review for Shoreline Stabilization at 10664 Madrona Drive, North Saanich, BC.

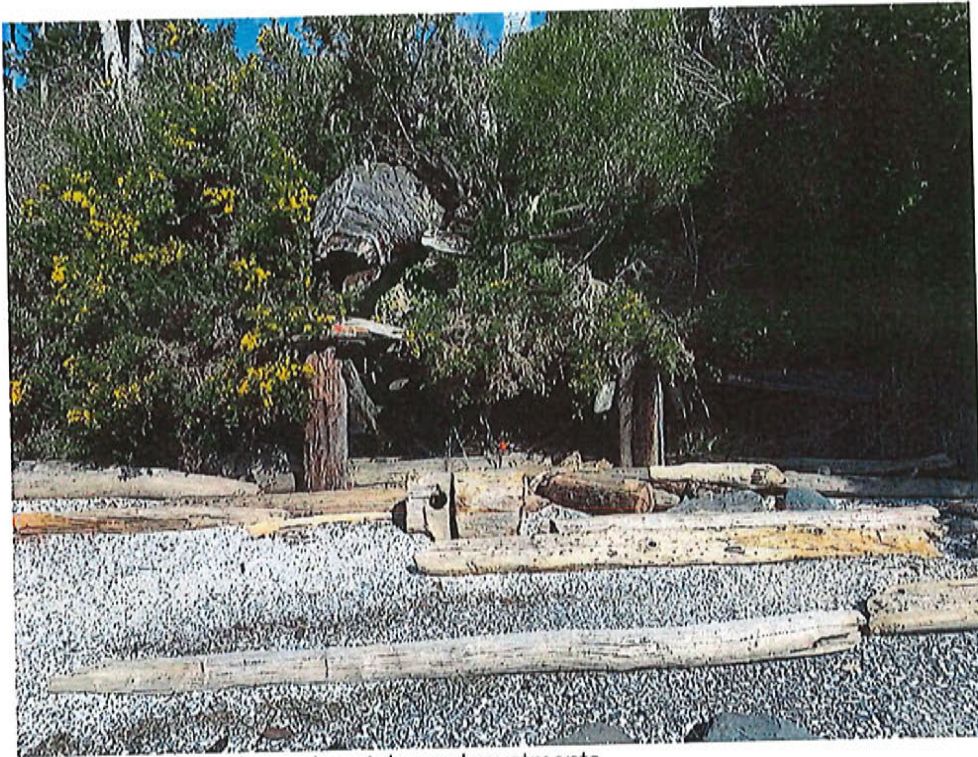
Photo 11. Historical wooden stairs and revetments.

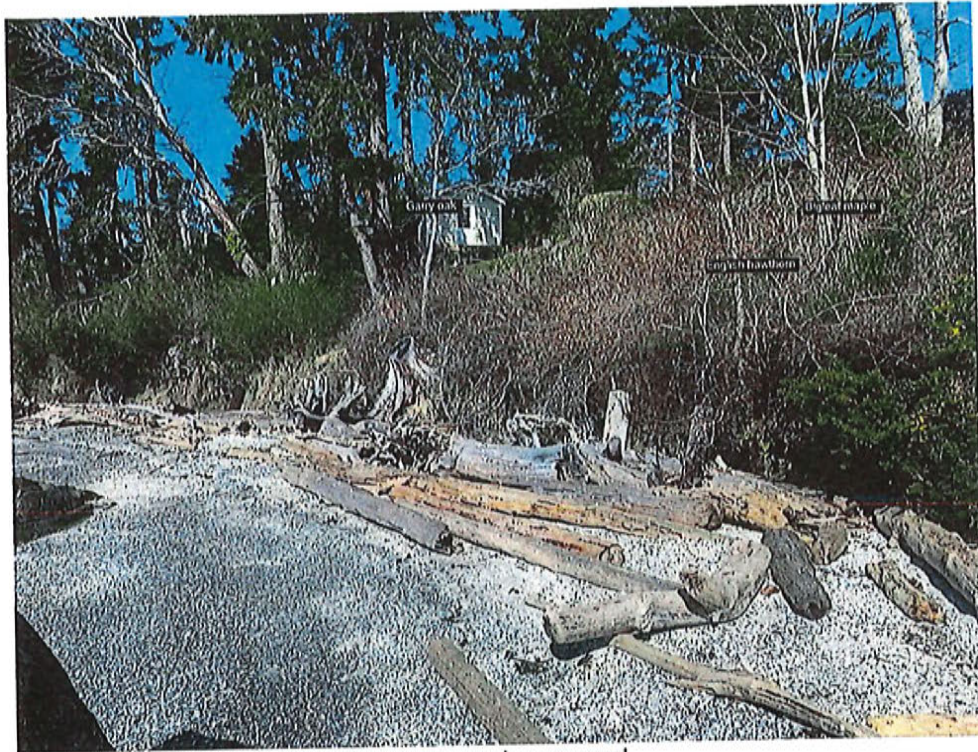
Photo 15. Three small trees that may require removal.

No large trees are proposed for removal for the work. Three small trees on the lower slope (bigleaf maple, Garry oak, and the invasive, non-native English hawthorn) may require removal: if they are removed, they will be replaced at 1:1 with native species (Figures 2, 3, and 6, and Photo 15).

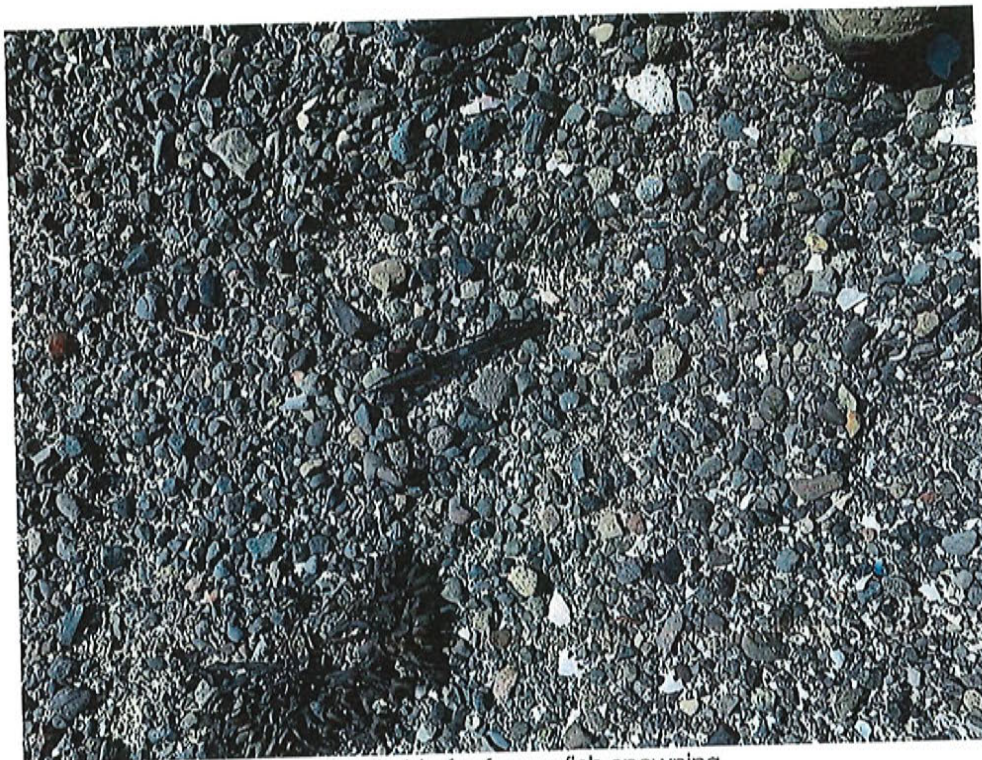
Photo 18. Beach substrate, suitable for forage fish spawning.
