**District of North Saanich
Community Agricultural Commission
Regular Meeting
Wednesday, September 11, 2019 at 1:30 p.m.**

This Closure of Reclamation Activities report is a summary of the current reclaimed agricultural status of Sandown Agricultural Property. This report is a product of observations, made during a June 26, 2019 field review, of reclamation activities intended to resolve deficiencies noted in previous assessment for substantial completion of agricultural reclamation activities¹, and evaluation of all prior reclamation and drainage management activities on the Sandown Agricultural Property. This letter style report is intended to only address previously noted deficiencies, and any pertinent agricultural concerns noted at time of the recent field review, toward establishing closure of agricultural reclamation under purview of the proponent.

PROJECT:
Agricultural Land Reclamation Assessment and Preliminary Drainage Plan

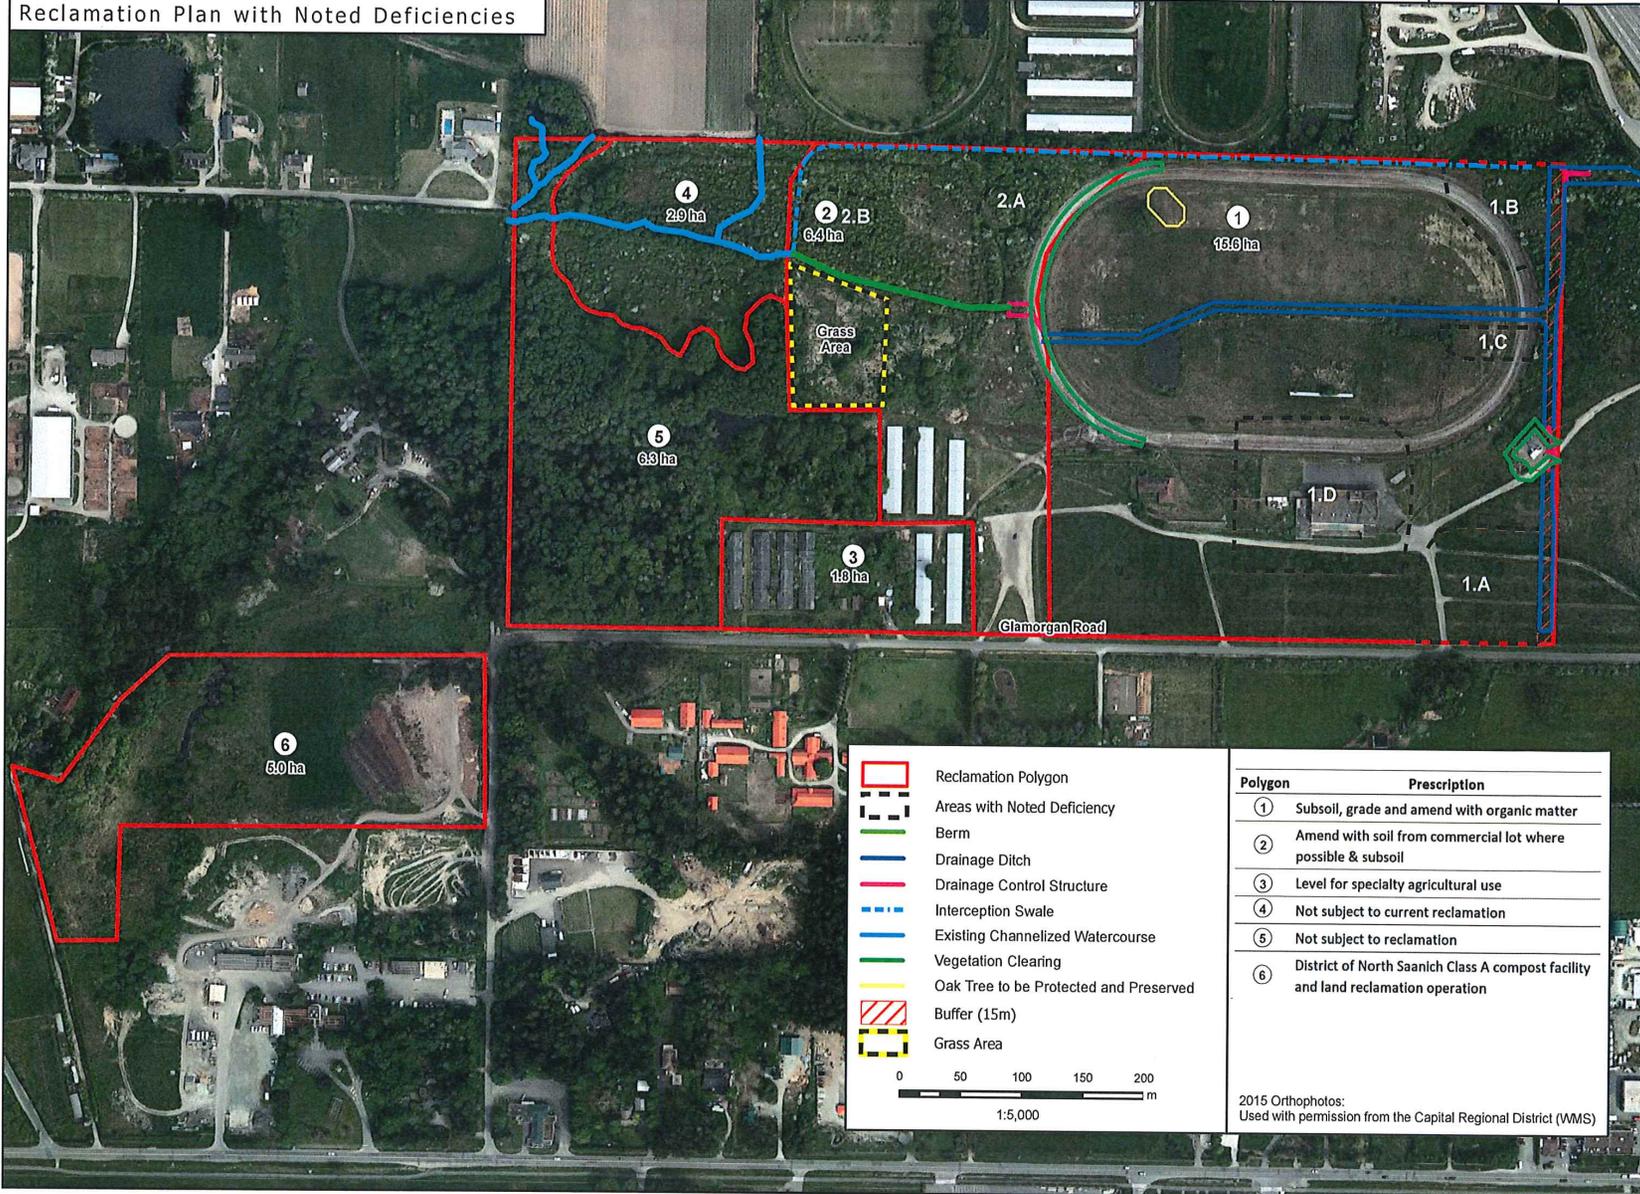
Reclamation Plan with Noted Deficiencies

The reclamation activities for each polygon and the observations and QP evaluation of completion are summarized in the table below, which should be read in conjunction with the annotated map provided. The map is annotated with areas that correspond to the numeration of noted deficiencies/recommendations in Table 1 below.

- Reclamation Polygon
- Areas with Noted Deficiency
- Berm
- Drainage Ditch
- Drainage Control Structure
- Interception Swale
- Existing Channelized Watercourse
- Vegetation Clearing
- Oak Tree to be Protected and Preserved
- Buffer (15m)
- Grass Area

Polygon	Prescription
①	Subsoil, grade and amend with organic matter
②	Amend with soil from commercial lot where possible & subsoil
③	Level for specialty agricultural use
④	Not subject to current reclamation
⑤	Not subject to reclamation
⑥	District of North Saanich Class A compost facility and land reclamation operation

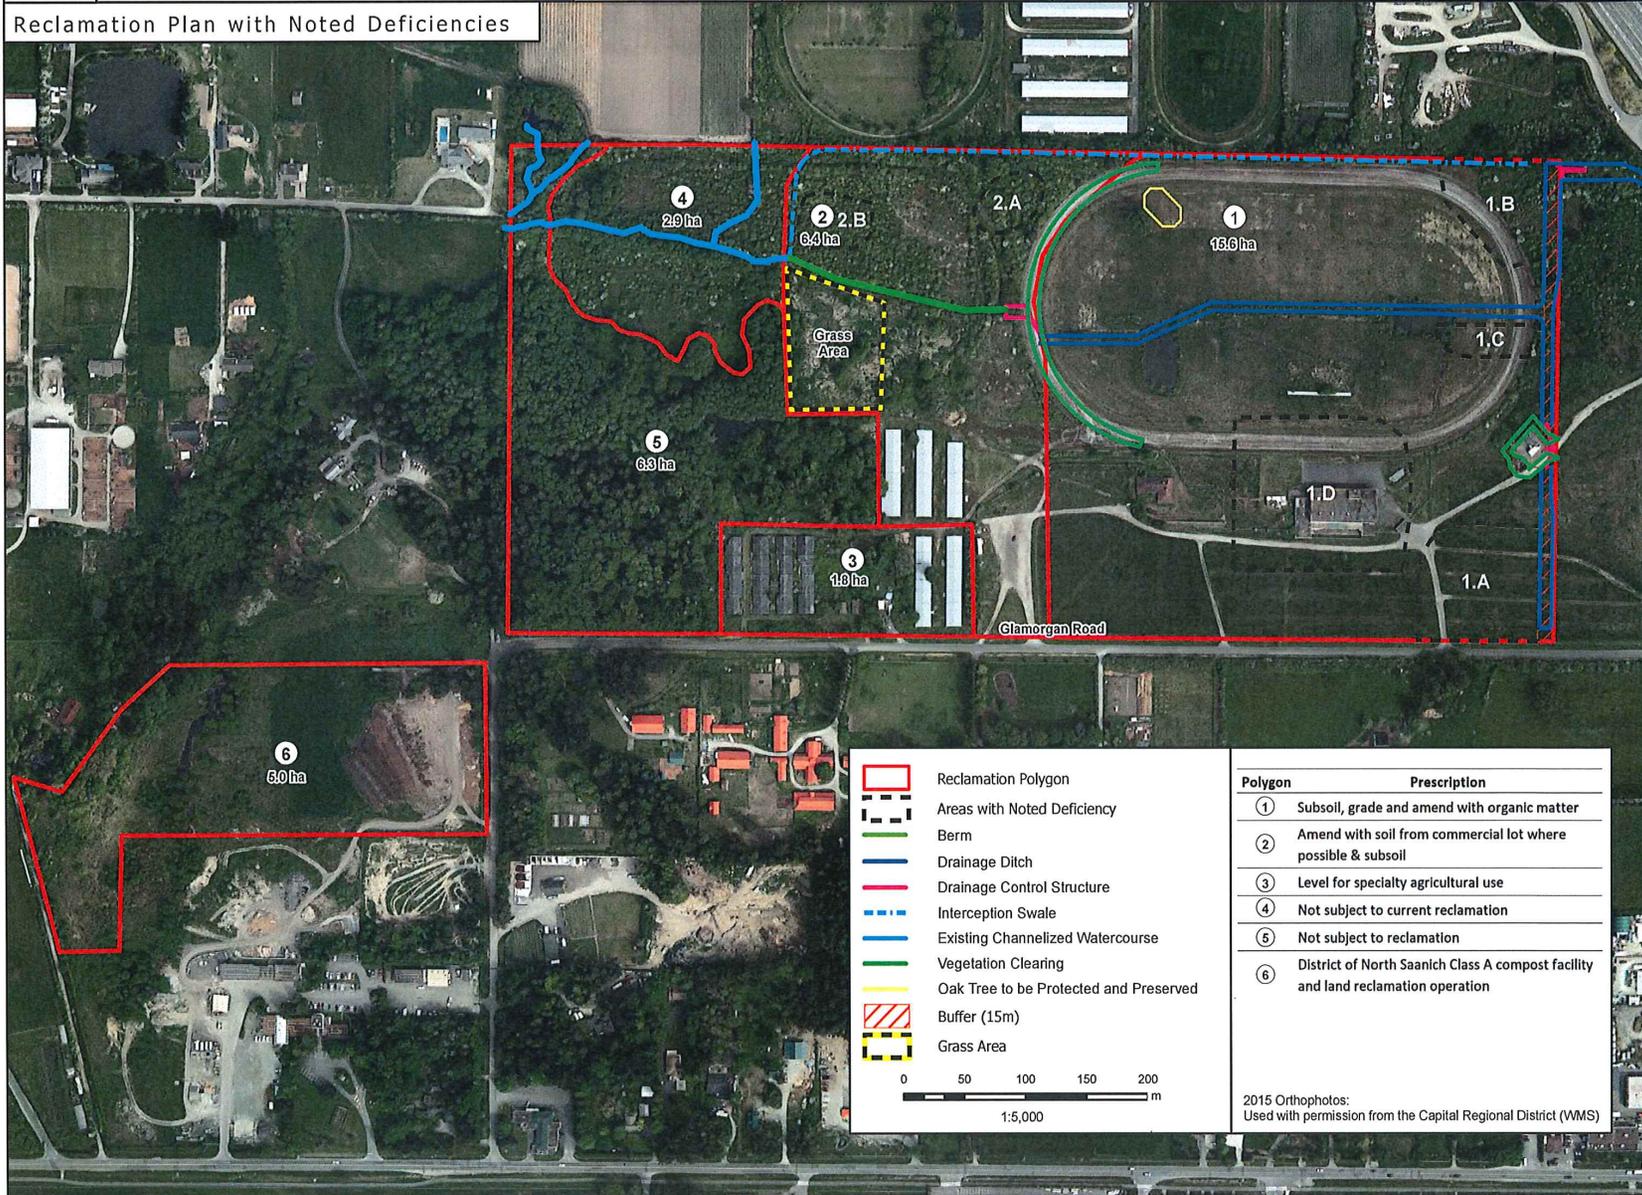
Reclamation Plan with Noted Deficiencies

The reclamation activities for each polygon and the observations and QP evaluation of completion are summarized in the table below, which should be read in conjunction with the annotated map provided. The map is annotated with areas that correspond to the numeration of noted deficiencies/recommendations in Table 1 below.

drainage works (1.C), as indicated on the associated map, the reclamation will be completed through tillage as noted in Map 1 and Tables above.

Based on conditions during the final Site inspection and on previous observations, Madrone recommends the following reclamation activities:

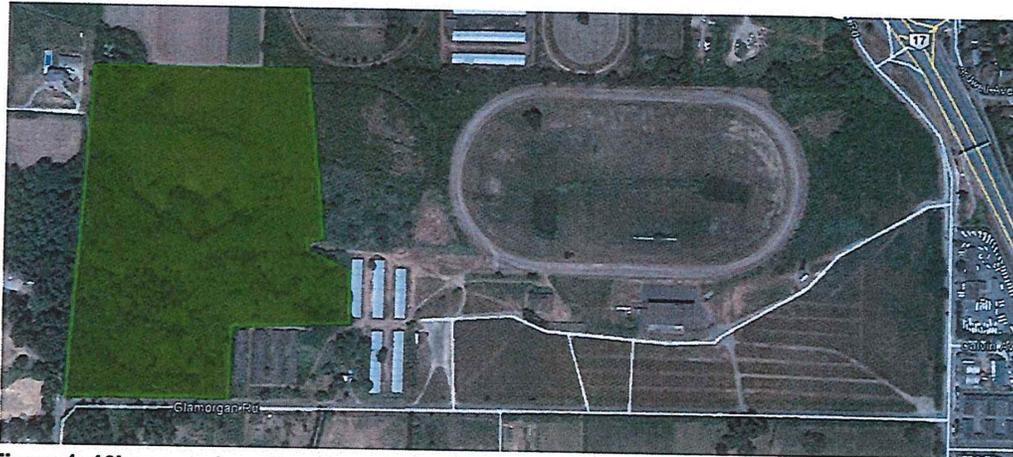
Figure 1: 10ha no-reclamation area

Response: This area shows ponding water, which is indicative of a high perched soil and low decomposition rate. The plan has been updated to reflect the 10ha area exception provided in the PDA. The exclusion in the PDA applies to approximately 10ha, described as being in the southwest portion of the Agricultural Land; therefore, the proponent is not excluded from including the northwest portion of the property in the reclamation plan. The updated plan notes that due to drainage and climatic considerations the reclamation of the marginal clayey loam lands in the north and west of the property and an area surrounding Wsikem creek in the portion of the site is not recommended in order to maintain the forested hydrologic "buffer" area that currently favorably reduces the rate of water leaving the Agricultural Land into the Munro Rd. drainage.

Incidental grading of the soils beneath the stables, which would occur through works associated with their removal, could create a space suitable for specialty agriculture (such as greenhouses). However, additional amendments would be required to render the soils suitable for general agriculture, which could be achieved with future soil importation from the VAA lands and would be beyond the scope of the proposed reclamation plan. These lands have been identified within the reclamation area in the updated plan. Please refer to Figure 1 below, obtained from the updated plan.

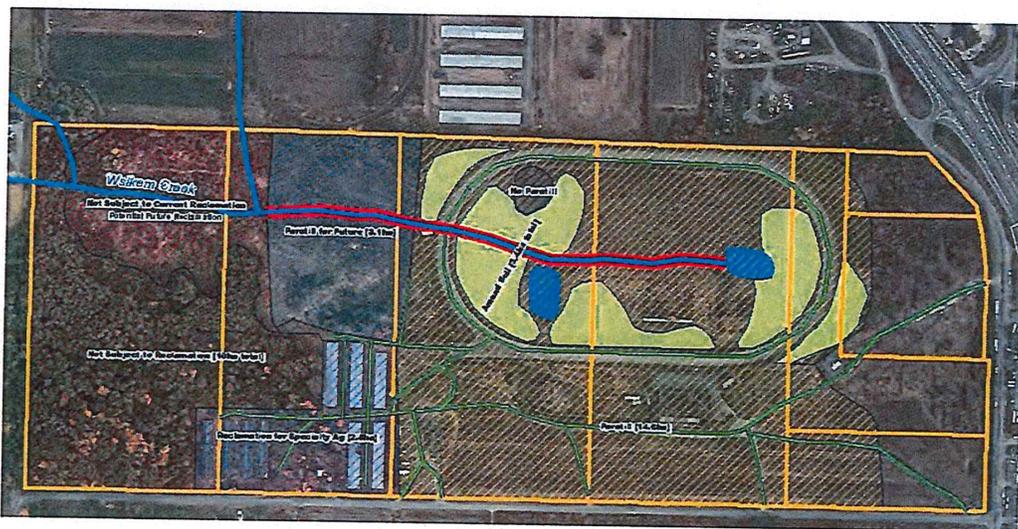
Figure 2: Updated Reclamation Plan

Figure 2, below provides an updated version of the reclamation and drainage site plan, which includes the approximate location of the 10ha portion of land not proposed for reclamation and two new areas to undergo paratilling and grading for reclamation towards specialty agriculture and future reclamation by the District.

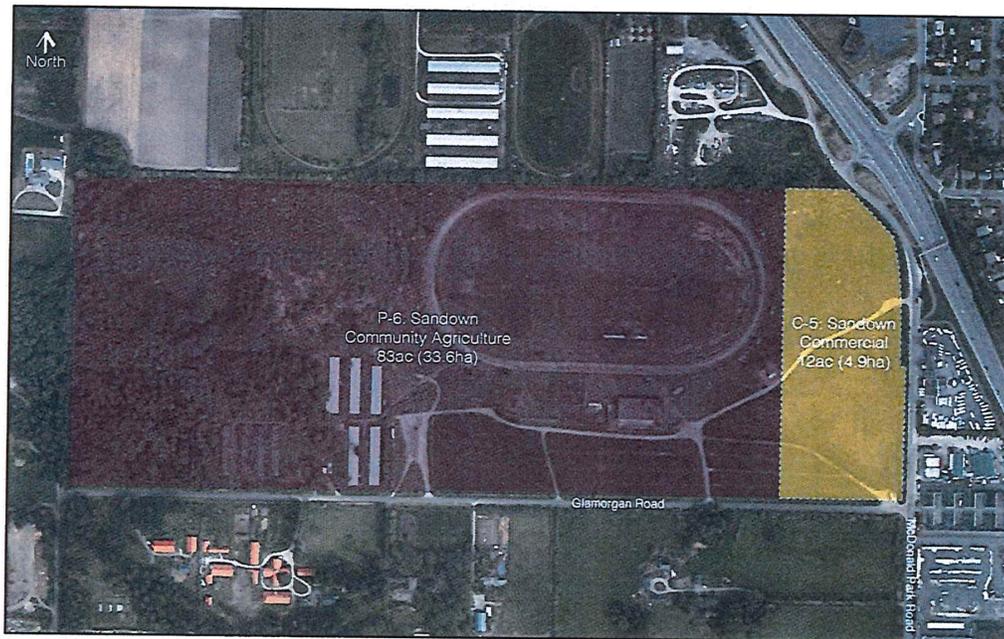
Figure 1 – Sandown Site

In 2014, Council adopted a bylaw to authorize a Phased Development Agreement (PDA) for a commercial development on the western portion of the former Sandown Raceway site on Glamorgan Road. This was a complex process which required Agricultural Land Commission (ALC) approval as the proposal involved the exclusion of the commercial site, and the inclusion of additional land to the Agricultural Land Reserve (ALR) in order to ensure there was no net loss to the reserve. As a result, the ALC's approval was conditional upon various criteria, one of which was the requirement that the developer engage an agrologist to prepare a drainage and agricultural reclamation plan for the remaining 83 acre agricultural portion of the Sandown Raceway site.

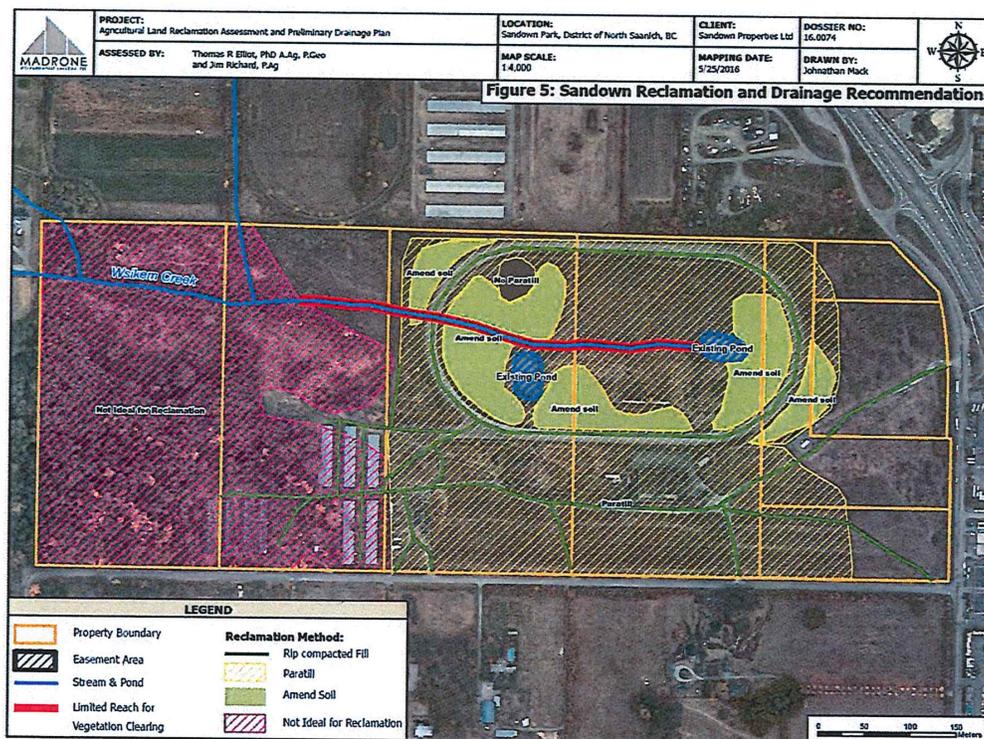
Figure 2 – Sandown Reclamation and Drainage Recommendations

The proposed methods of soil reclamation are considered to be mechanisms which will in turn improve the drainage in the reclaimed area as they are intended to assist in improving the excess free water limitations that currently exist in that area. Two existing ponds which drain to Wsikem Creek are proposed to be maintained. Limited re-activation of Wsikem Creek in the proposed reclamation area, through removal of excess vegetation and silt-dredging, is recommended to ensure that there is sufficient gradient to transport any excess water from the reclaimed agricultural lands. The nascent forest and marsh lands immediately adjacent to the creek would be retained and intended to provide stormwater detention.

The report suggests that if the recommendations for mitigating limitations to agriculture are implemented there is no anticipated material change in off-site storm water peak flow volume. However, an engineering analysis of the site hydrology and hydraulics, including assessment and quantification of runoff, regrading requirements, existing and future conveyance capacity of the creek within the site, on-site stormwater storage capacity, and constraints to discharge (elevation and quantity) from northwest portion the site were not completed as part of the plan.

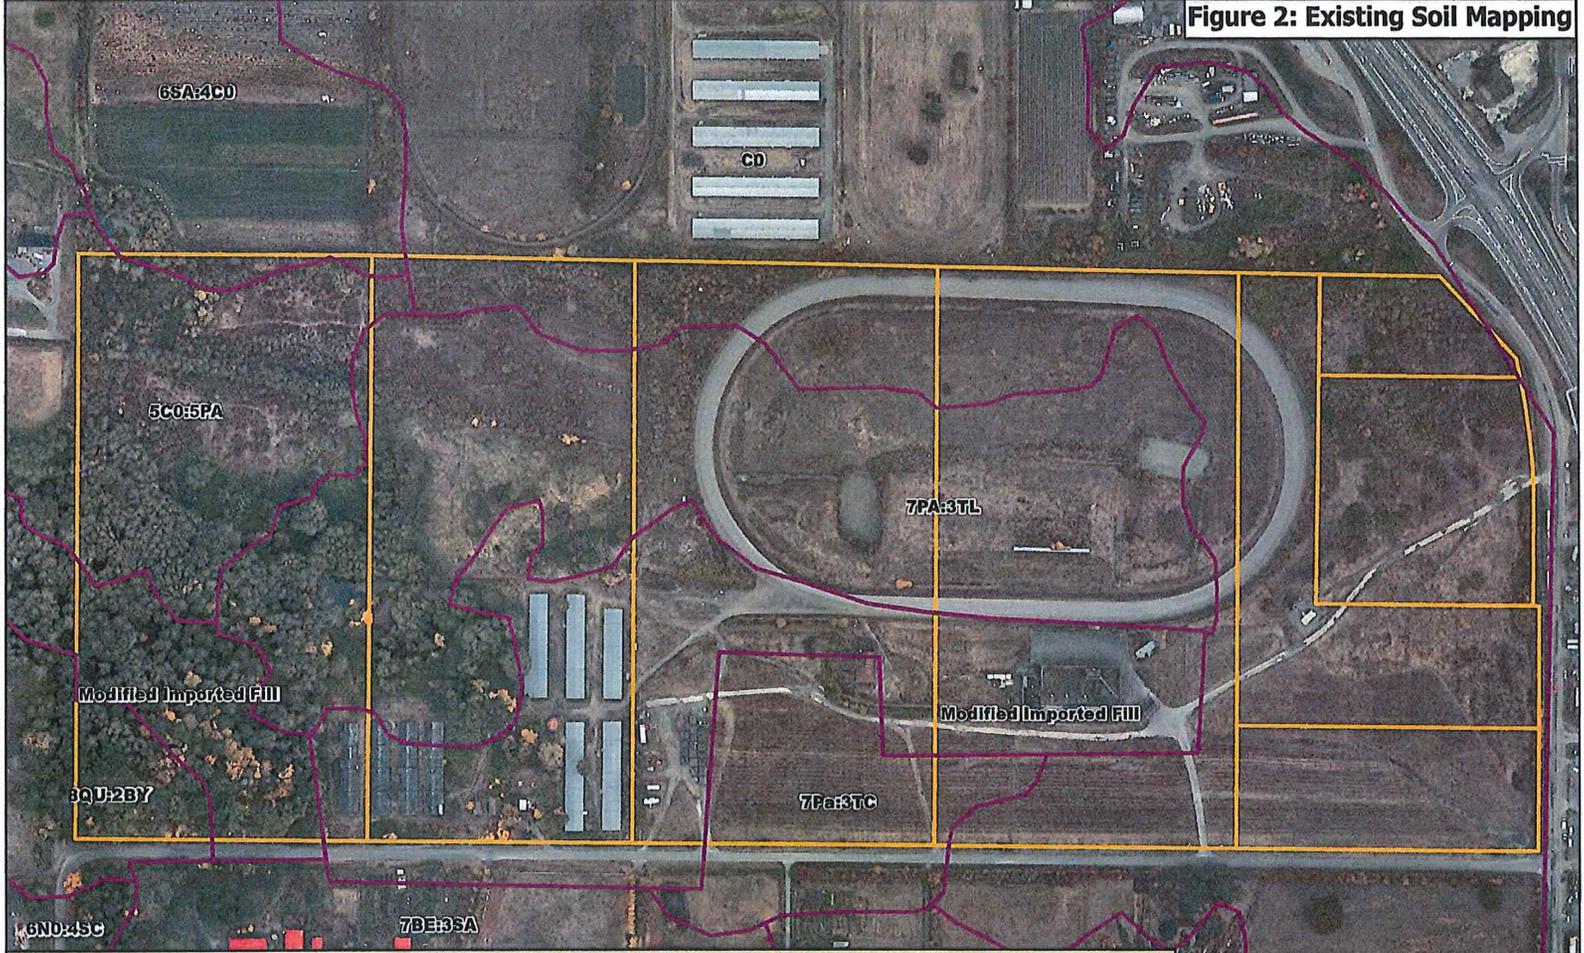
Figure 2: Existing Soil Mapping

- Property Boundary
- Soil Type Polygon
- Soil Region:**
- CO = Cowichan (Silty clay loam or silt loam marine deposits)
- SA = Saanichton (Silt loam and silty clay loam marine deposits)
- PA = Parksville (Between 30cm and 100cm of sandy loam or loamy sand marine deposits over silt loam or silty clay loam marine deposits)
- TL = Tolmie (Between 10 and 30 cm of sandy loam or loamy sand marine deposits over silty clay loam marine deposits)
- BE = Brigantine (loamy sand or sandy loam fluvial and marine deposits over silty marine deposits)
- BY = Baynes (loamy sand or sandy loam fluvial or marine deposits)

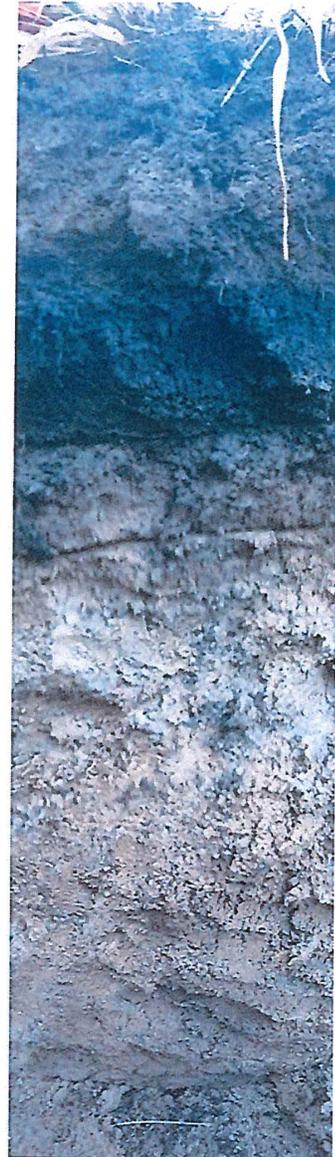
HORIZON	DEPTH (CM)	DESCRIPTION
Ah	0 - 10	Dark grayish brown (10YR 4/1) to black (10YR 2/1); sandy loam modified organic accumulation; numerous fibrous roots; medium granular structure with a smooth boundary.
Bhgj	10 - 25	Black (10YR 2/1) to gray brown (2.5YR 3/1) silt loam organic carbon accumulation; numerous fine fibrous roots; medium granular structure with a diffuse boundary.
Bfmg	25 - 55	Gray brown (2.5YR 3/1) to medium gray brown (2.5Y 6/4) silt loam; sparse fine roots; iron mottles with a fine granular structure forming an irregular boundary.
Cfmg	55 - 110+	Light reddish brown (2.5Y 6/3) silt loam; gleying and iron mottles with a fine granular/massive structure.

Photograph 1. Soil Pit 1 [SP01]
Comments: Orthic Humic Gleysol of the Parksville Soil Series.

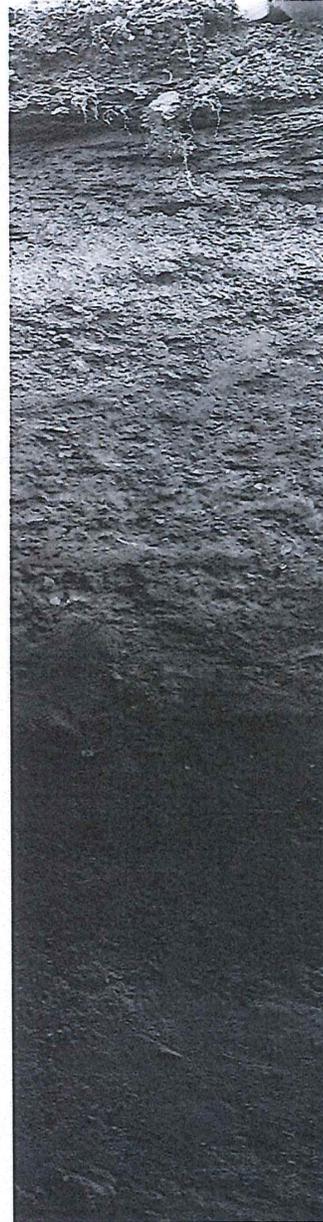
HORIZON	DEPTH (CM)	DESCRIPTION
Technosol	0 - 50	Gray, compacted imported crushed gravel with abrupt interface.
Technosol	50 - 75	Light brown (7.5YR 4/6) to reddish brown (7.5YR 5/8) imported sand/silt mixture, intersected at middle by gravel layer; abrupt transition.
Bhmj	75 - 100	Dark brown (5YR 2.5/1) compacted silt loam; mottled with massive structure.
Cmg	100 - 160+	Dark gray (2.5y 6/3) mottled and gleyed sandy silt material with medium granular structure and diffuse transition.

Photograph 2. Soil Pit 2 [SP02]
Comments: Orthic Humic Gleysol of the Parksville Soil Series.

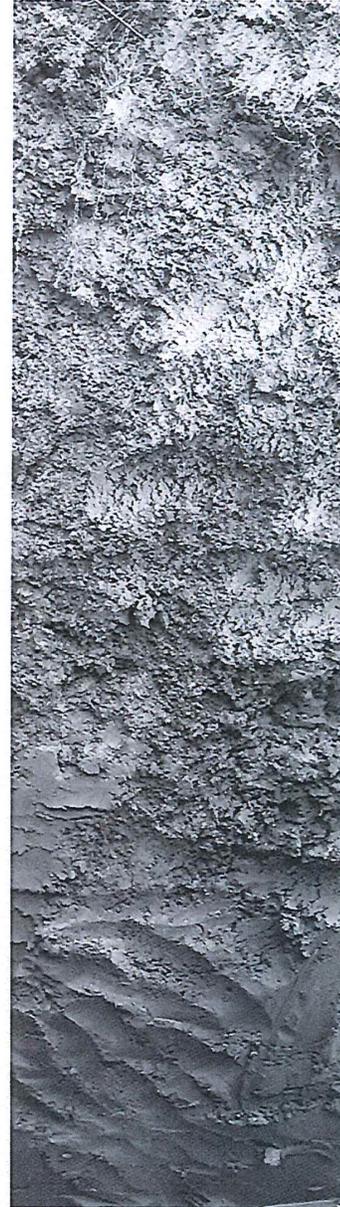
HORIZON	DEPTH (CM)	DESCRIPTION
Be	0 - 10	Light grayish brown (2.5Y 6/1); silt loam; numerous fibrous roots; fine granular structure with a disrupted boundary.
Bt _{fmg}	10 - 55	Medium gray brown (2.5Y 4/3) silt loam; sparse fine fibrous roots; fine granular structure with ferric mottles and gleying ending with a diffuse boundary.
C _{mg}	55 - 150+	Light gray brown (2.5Y 4/2) silt; gleying and with a fine granular/massive structure.

Photograph 3. Soil Pit 3 [SP03]
Comments: Orthic Humic Gleysol of the Cowichan Soil Series.

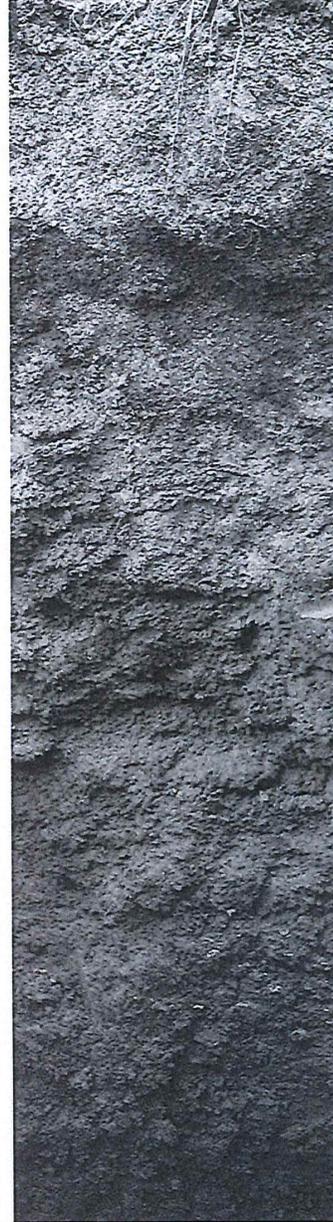
HORIZON	DEPTH (CM)	DESCRIPTION
Technosol	0 - 20	Light gray crush gravel; compacted.
Ahgj	20 - 35	Brown black (7.5YR 3/1) to dark gray brown (10YR 5/4) silt loam with accumulated organic carbon; fine fibrous roots; medium granular structure with a diffuse/inconsistent boundary.
Bfmg	35 - 50	Light reddish brown (10YR 5/4) silt loam; distinct iron mottles with a medium granular structure forming an irregular boundary.
Cm	50 - 160+	Light gray brown (2.5Y 4/2) silt loam to silt; gleying with a fine granular/massive structure.

Photograph 4. Soil Pit 4 [SP04]
Comments: Orthic Humic Gleysol of the Cowichan Soil Series.

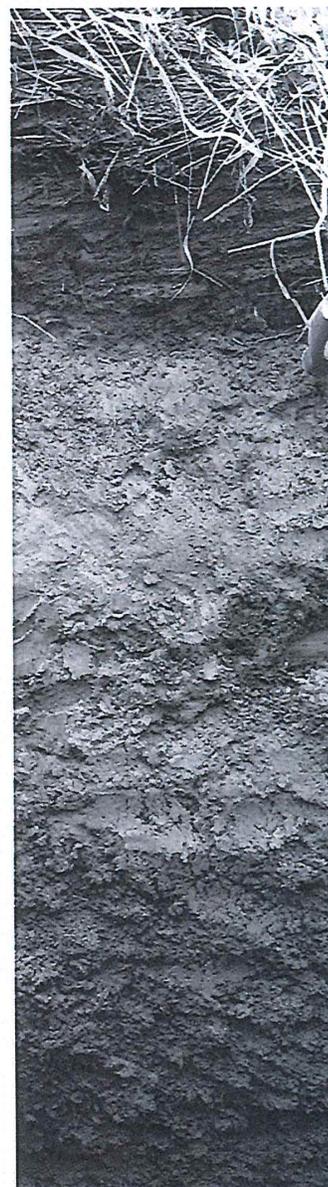
HORIZON	DEPTH (CM)	DESCRIPTION
Ahg	0 - 25	Gray black (10YR 3/1) to black (10YR 2/1); gleyed clay loam organic accumulation; numerous fibrous roots; medium granular structure with a smooth boundary.
Bgm	25 - 65	Gray black (10YR 3/1) gleyed and mottled silt loam; numerous fine roots; fine granular structure with a diffuse to irregular boundary.
Bfmg	65 - 90	Reddish gray black (10YR 5/3) ferric mottled and gleyed silt loam; fine granular structure forming an irregular boundary.
Cmg	90 - 180+	Light brown (2.5y 4/2) mottled and gleyed silt loam, coarse granular texture.

Photograph 5. Soil Pit 5 [SP05]
Comments: Orthic Humic Gleysol of the Cowichan Soil Series.

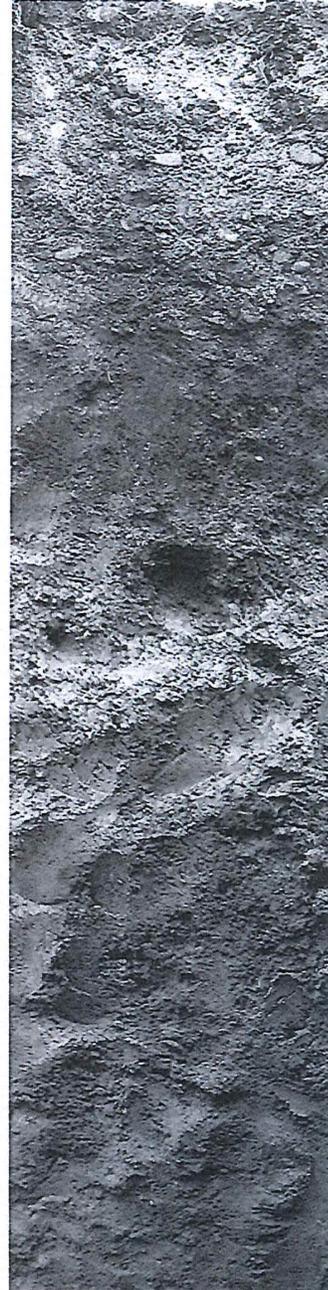
HORIZON	DEPTH (CM)	DESCRIPTION
Technosol	0 - 30	Light gray crushed coarse and compacted imported gravel.
Ahgi	30 - 55	Medium gray brown (5YR 2.5/2) organic carbon enriched loam with sparse fine roots with minor gleying.
Bfmg	55 - 70	Light gray brown (10YR 4/3) silt loam; iron mottles with gleying of a fine granular structure forming an irregular boundary.
Cmg	70 - 180+	Medium reddish brown (7.5YR 5/1) silt loam; gleying and iron mottles with a fine granular/massive structure.

Photograph 6. Soil Pit 6 [SP06]
Comments: Orthic Humic Gleysol of the Parkville Soil Series.

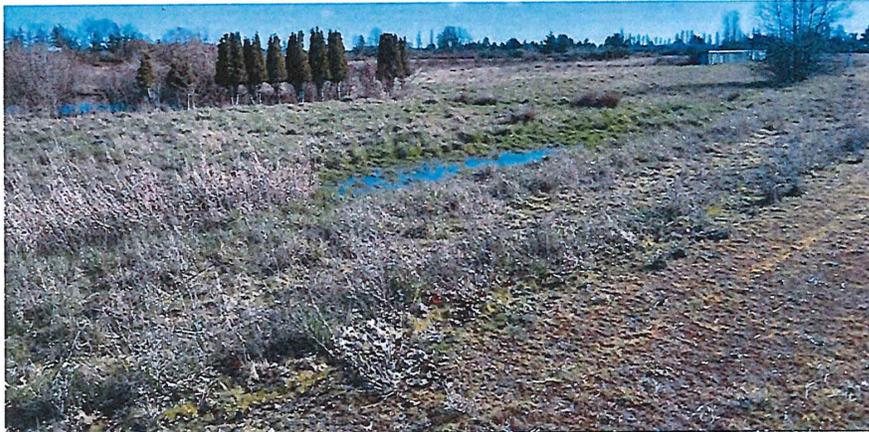
Photograph 1 – Mid section of the Site looking northeast, near SP01, across the track infield (track surface in foreground). Note the standing water in foreground and artificial pond in the background.

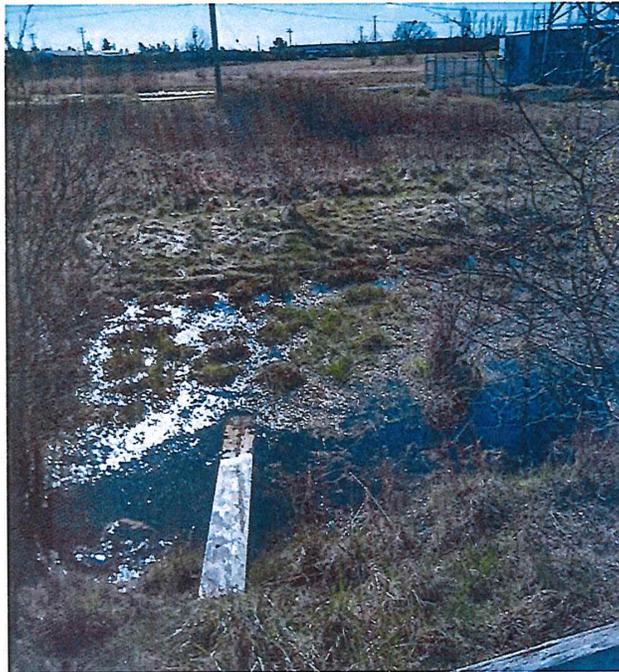
Photograph 2 – Looking southeast from the southeastern corner of the track near SP02. Note the extensive ponding of water at surface in the fore and background.

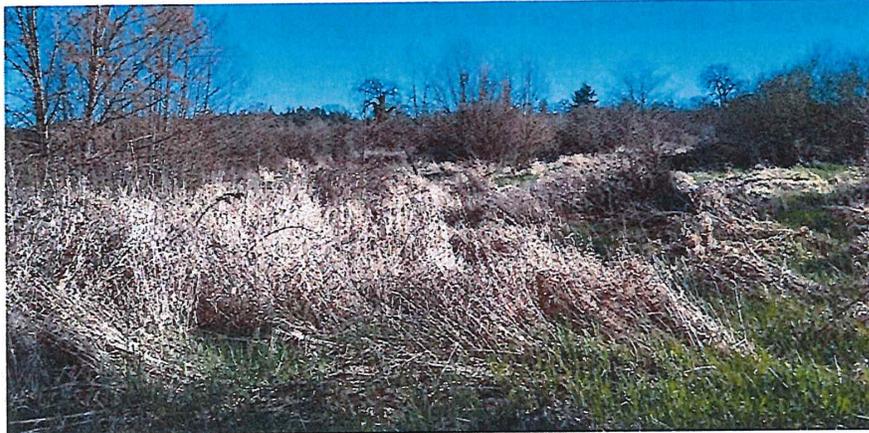
Photograph 3 – West section of the Site looking north across the abandoned and derelict historic track near SPO5. Note the wetland grass and standing water in foreground.

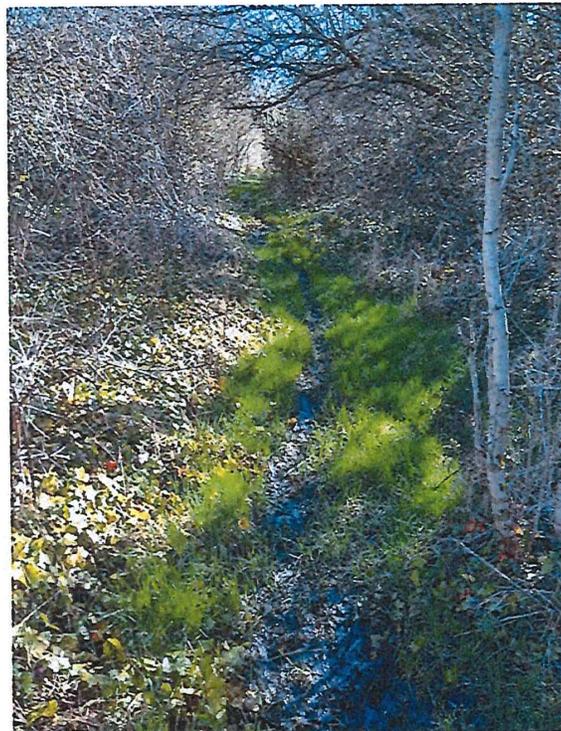
Photograph 4 – Looking east along the remnant of the old track at north boundary of Site. Note the excess water at surface in the foreground and background.

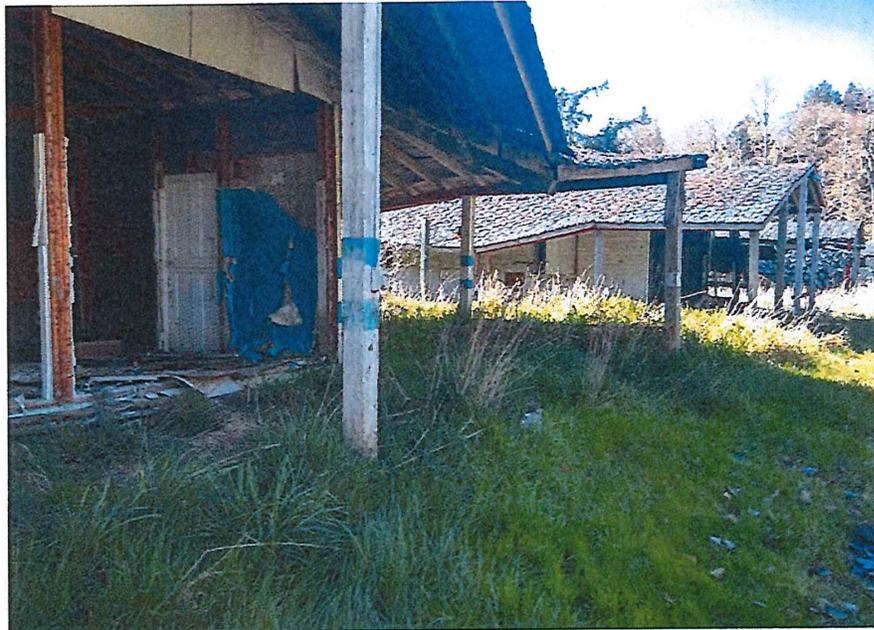
Photograph 5 – North of the derelict stables on Site looking west, near SP06. Note the raised ground level of the old stable structures to keep the surfaces relatively dry.

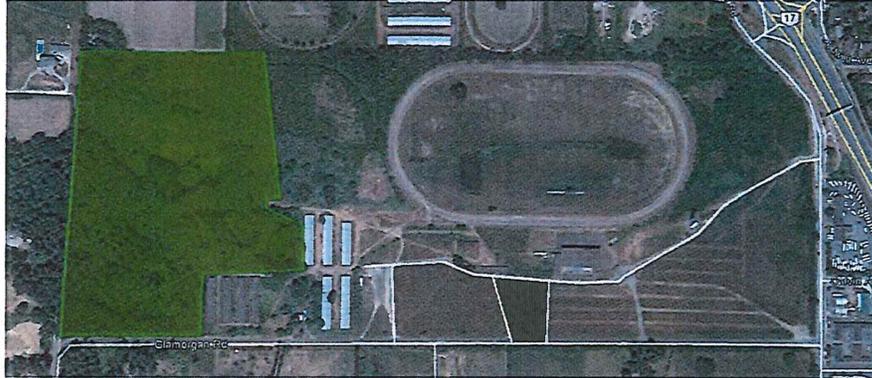
The forested area set aside from reclamation by the PDA is estimated in the following Google Earth image. While there was no map of the area available at time of writing, a description was used in conjunction with field observations and landform to inform and establish a 'no-reclamation' area to optimize future potential for agriculture on the remaining property. The area presented in Figure 1 is not required to be reclaimed by the PDA.

Figure 1 – The 10 hectare 'no-reclamation' area to be excluded from reclamation as per the PDA. The green area indicated is 10 hectares and was laid-out based on field observations and written description (i.e. '10 ha portion [sic] that is treed...' – PDA Schedule A, Section 2) of the area not required to be reclaimed by the PDA.

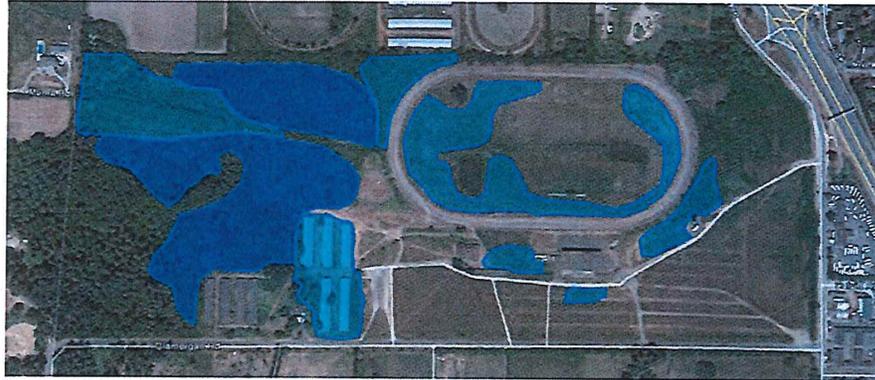
The primary limitation to agriculture was observation of free flowing excess soil moisture at surface within the west-central portion of the site, which is a Class 5W limitation. The widespread occurrence of the 5W limitation was confirmed in soil pit, vegetation type and exploratory holes.

Furthermore, there was inundation limitation at class 2I in the far west of the property and area surrounding Wsikum Creek upstream of Munro Road. The 2I level of occasional inundation during the growing period would affect crops within this area, and potentially affect perennial crops through winter inundation. The areas of inundation noted during field assessment of the Agricultural Lands are shown in Figure 2 below:

Figure 2 – Excess water (purple) and Inundation (light blue) limitations to agriculture. Please note, these limitations present to varying degrees within these areas. I have not included areas of overlap for the purpose of clarity.

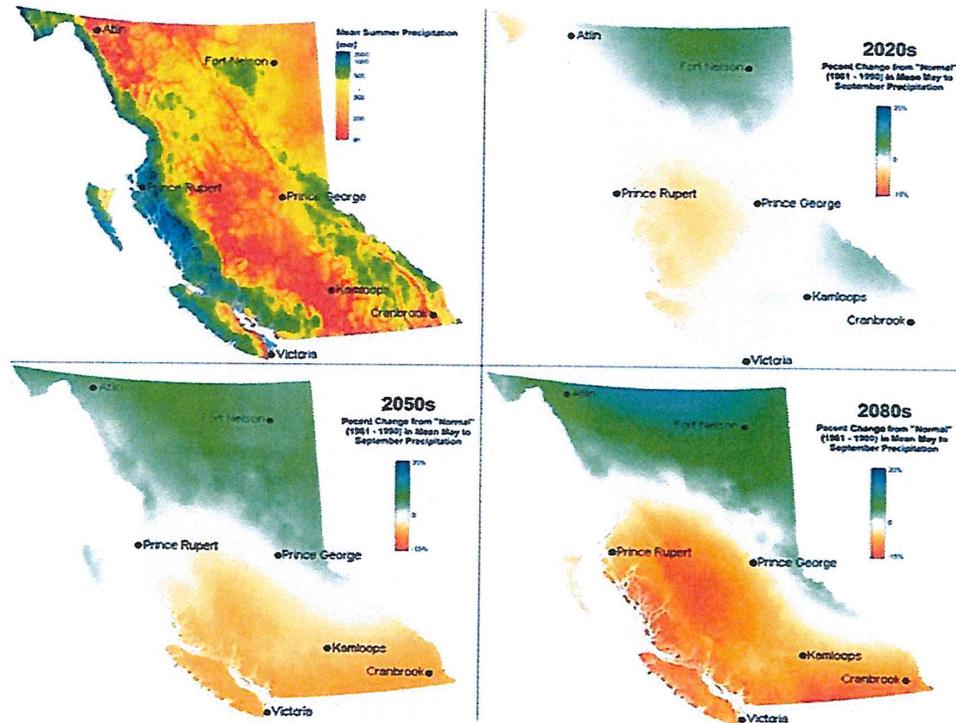
For the northwest portion of the Sandown property, I also had to consider the impact of changing precipitation trends and use of marginal agricultural lands in balance with downstream stormwater infrastructure. Particularly important were the predictions for less summer rain (Figure 3) and more winter rain (Figure 4) combined with the current capacity of Munro Road stormwater infrastructure and ALC direction to ensure 'proper' drainage on and from the property. Further, the composition of soil in the western portion of the property shifted toward a clayey loam at surface as opposed to a silt loam, which would result in a lower trafficability, or ability to travel over without sinking, by farm machinery if amended with soil from the eastern portion of the property (a silt loam), as per the ALC decision. Consequently, even if tilled and amended with available materials to improve drainage, the western portion of the Agricultural Land would have a soil structure limitation that could limit machine access during the planting and growing season until drought conditions drained the excess soil moisture.

Figure 3 – Predicted Change in Precipitation for Growing Season (May to September).

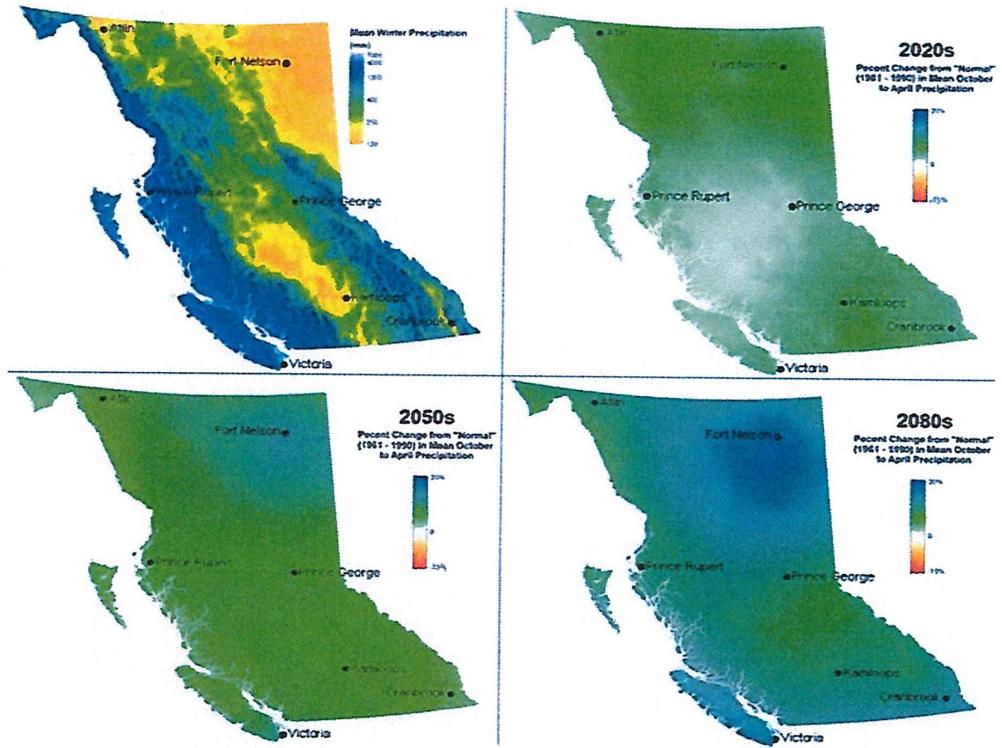
Figure 4 – Predicted Change in Precipitation from 'Normal' in Winter (October to April).

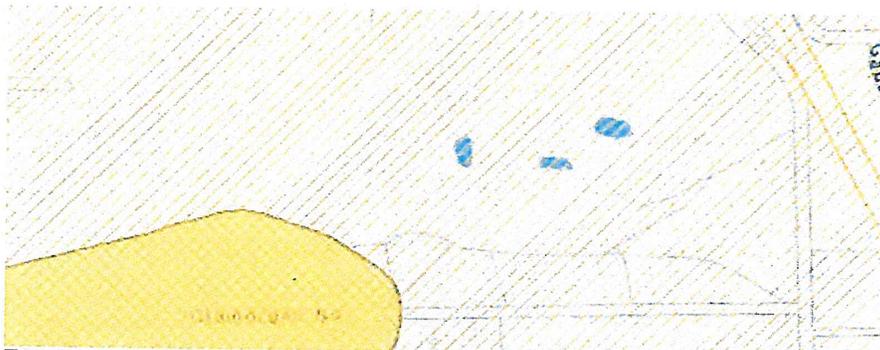
Figure 5 – Aquifer #609 (in yellow) with moderate vulnerability which underlies the forested southwest corner and Stable areas on the Sandown Property.

Alternatively, this area could be moderately graded in concert with removal of the stables so as to permit the installation of improvements for specialty agriculture that would benefit from road access (e.g. greenhouses or community farm store), should the DNS wish to make use of this area.

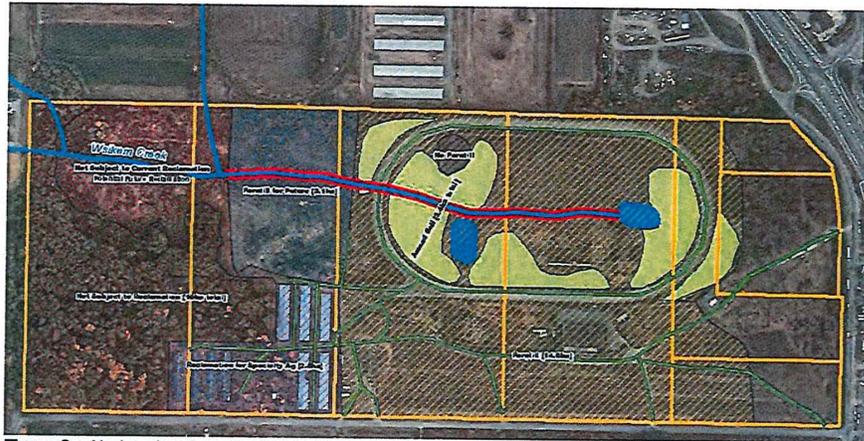
Please see an updated Figure 5 of the Reclamation and Preliminary Drainage Plan below.

Figure 6 – Updated reclamation figure indicating the approximate 10 ha of land not subject to reclamation as per the PDA. There were also two new areas identified (Amethyst and Blue hatch) to undergo grading and paratilling, respectively, for reclamation toward specialty agriculture and future reclamation by the DNS based on suitable agricultural soil availability. A potential future reclamation area has been identified, should the DNS wish to reclaim more of the Agricultural Land in the Future.
