Closure of Reclamation Activities

Sandown Agricultural Property

Glamorgan Road, District of North Saanich

Reclamation Plan at Closure

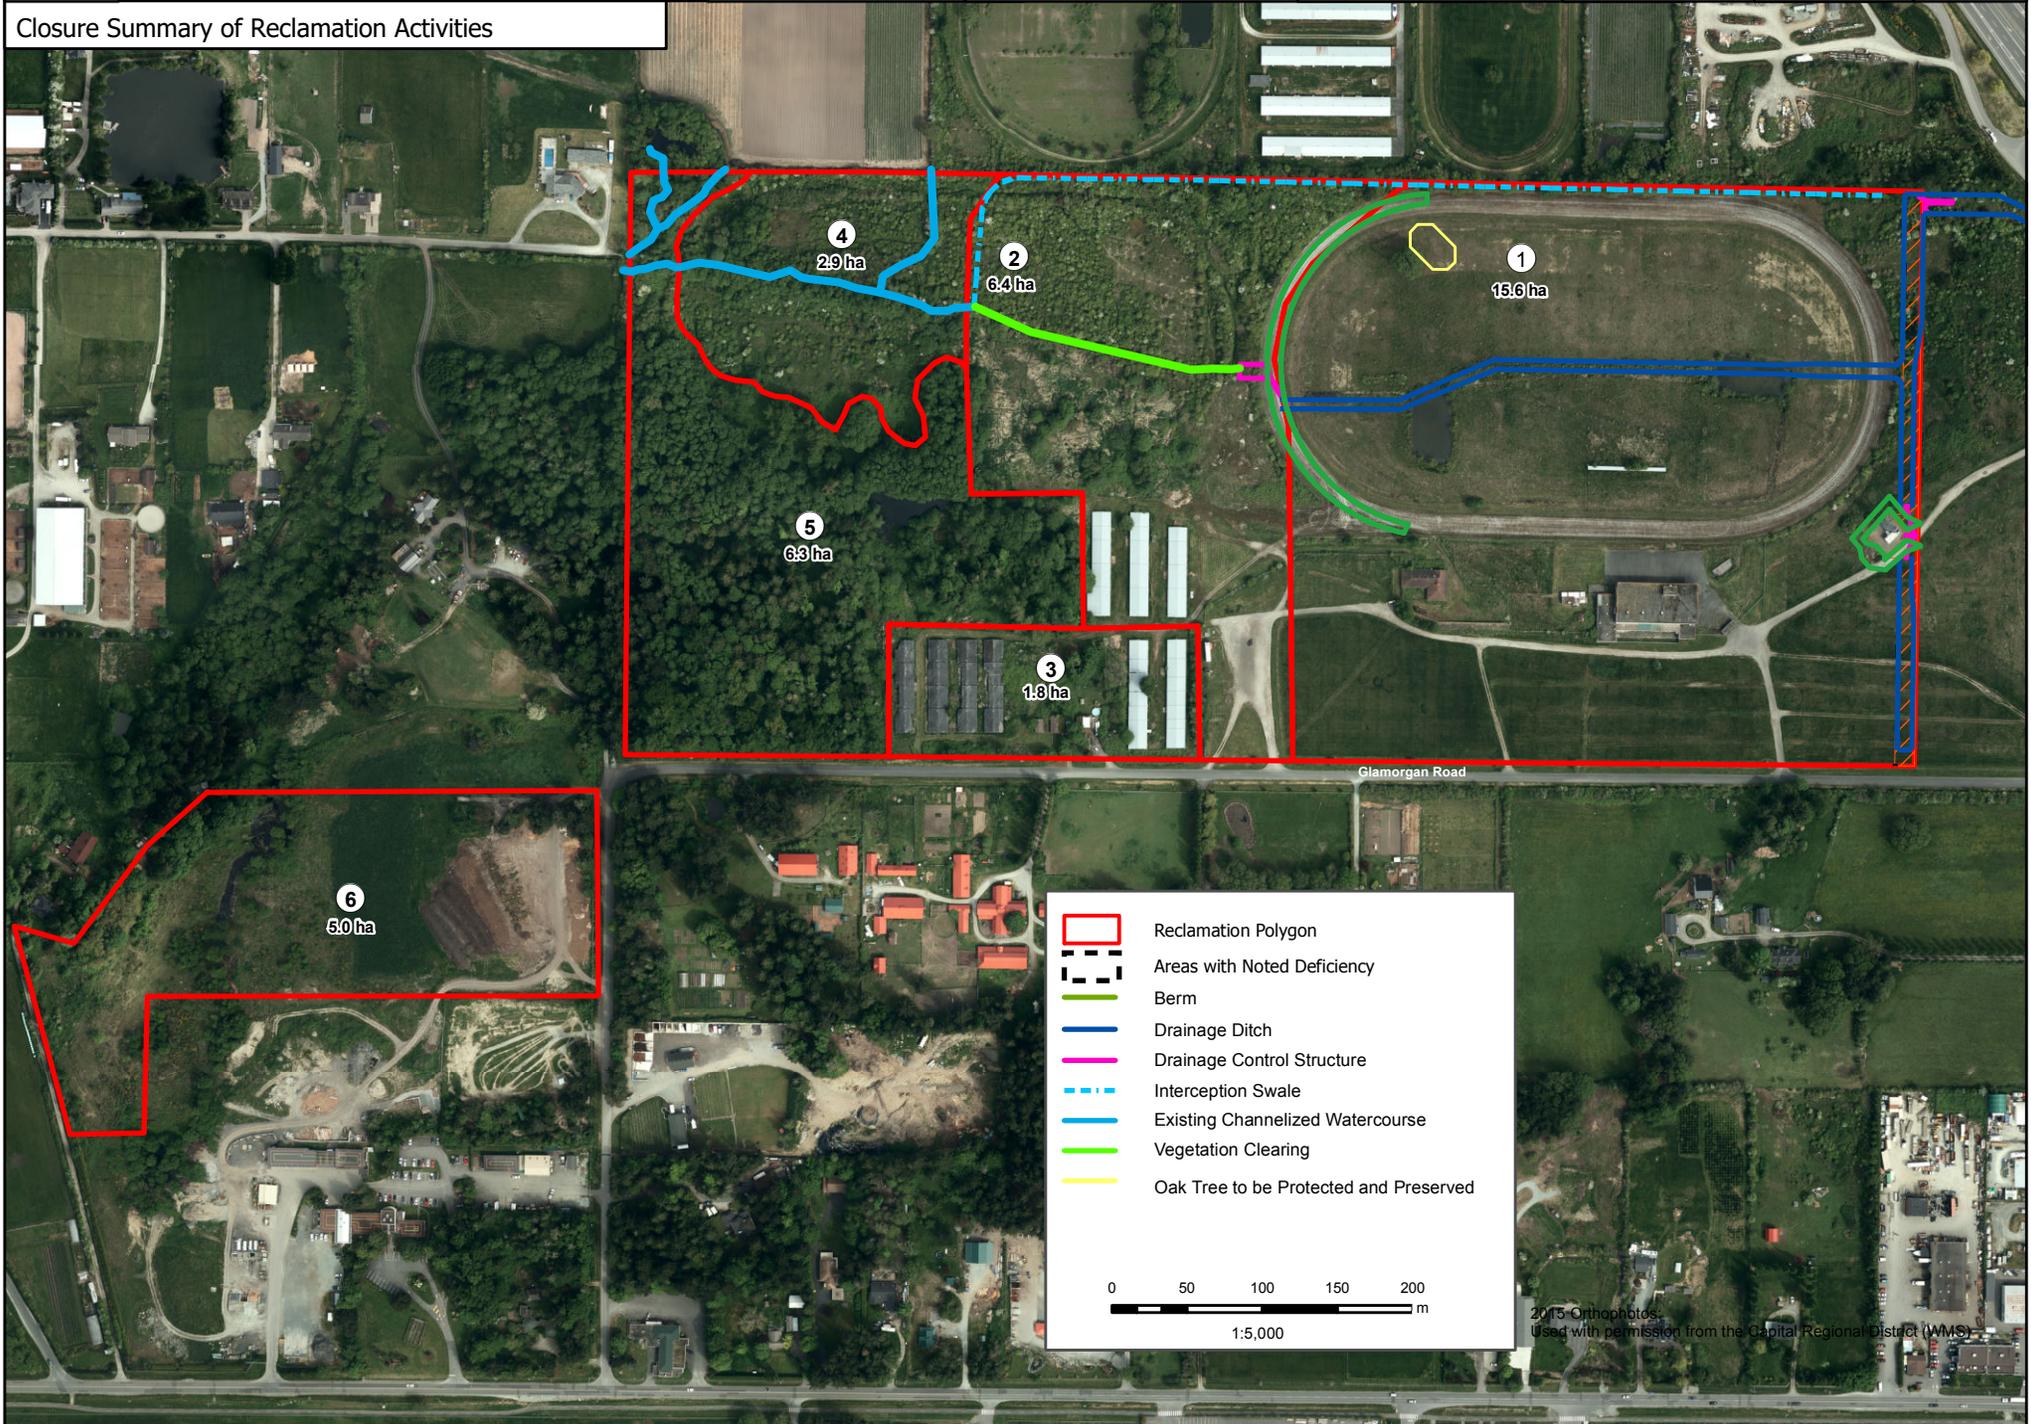
Closure Summary of Reclamation Activities

The reclamation activities for each polygon and the observations and QP evaluation of completion are summarized in the table below, which should be read in conjunction with the map provided. The map is annotated with Polygons that correspond to the numeration of noted deficiencies/recommendations in Table 1 below.
